Tree Roots and Development Case Study

Case Study : Development Within the Tree Root Protection Area

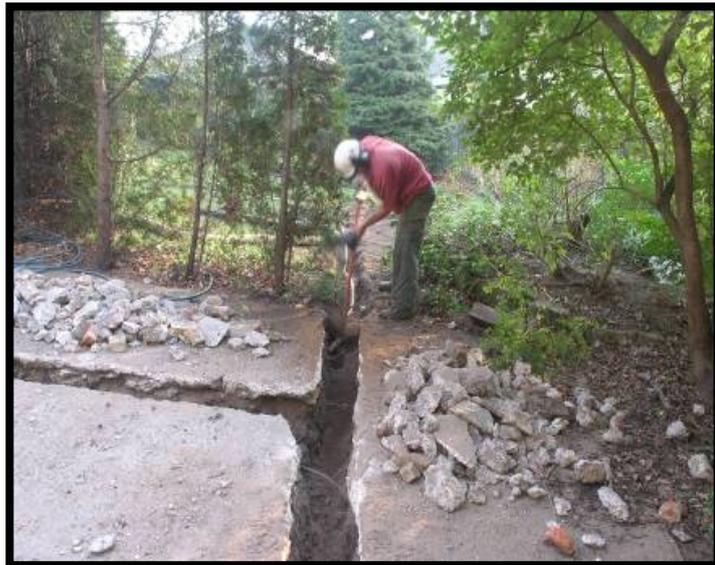
Tree roots found under the impermeable concrete, illustrated in this photograph, were clearly growing towards the area of garden that offered better rooting conditions. However, this area of garden was outside the RPA yet the roots found here could be consider as the most significant to tree health and survival.

A site meeting was then held with the tree officer, architects and client to discuss the result. It appeared that the tree roots were merely 'bridging' the area of hard surfacing in search of the more favourable rooting conditions outside of the designated RPA.

This information allowed the area utilised by the trees to be sufficiently protected whilst allowing a compromise to be met with consideration to the size and position of the extension. An agreement could be reached where the development is allowed within the RPA, on the basis that the area of consideration given to tree roots is extended to include the places where the tree is clearly gaining most benefit.

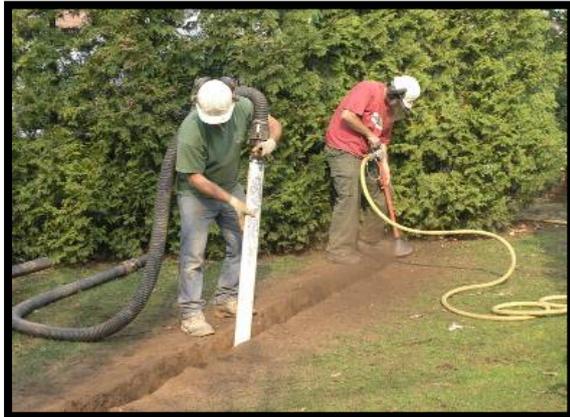
The proposed footings, along with another trench 5 metres from the gable end, were marked out by the architects and the concrete and crazy paving broken up. A 600mm deep trench was then excavated. The soil was broken up with an AirPick and removed using a soil vacuum unit. This method made it possible to retain even the smallest roots. The location and origin of root were then noted by using the proposed footings as a line transect.

The picture shows the AirPick and Soil Vacuum in action, with the soil being collected in a container to enable trenches to be filled back in following inspection.

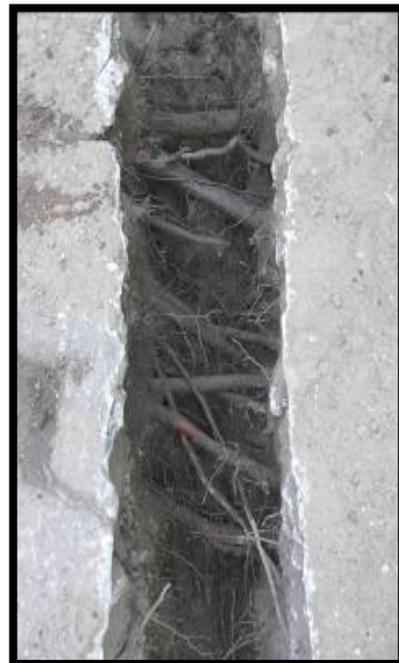
The picture (right) illustrates the extent of root growth under the impermeable concrete surface. This collection of Lime roots were traced across the hard standing area, in search of favourable rooting condition in the lawn.

The information gained from the site investigations could be presented to the LPA to help inform the planning application and the preparation of an Arboricultural Method Statement (AMS), which is written to support the proposed layout design with consideration to its construction in close proximity to trees.

When planning permission is granted for the development, the location of the roots can be passed onto the engineers so they can be considered and appropriately avoided during foundation design.
